Waterworks District 9, Ward 4 Meeting Minutes  
Regular Board Meeting  
Monday, January 9, 2023  
5:30pm – Conference Room

Water Works District No. 9, Ward 4  
Engineer's Report for January 9, 2023, Board Meeting  
Report issued: January 9, 2023

**PROPERTY DAMAGE INSPECTION REPORT**  
**BECKY'S CATERING LLC**  
**5121 Lions Road**  
**Sulphur, LA 70665**  
**January 5, 2023**

PROJECT NAME: Water Storage Tanks Rehabilitation Project  
PROJECT NUMBER: 19-007  
DOCUMENT DESCRIPTION: Property Damage at Becky's Catering & EWST #1 Site  
DOCUMENT DATE: 01/05/2023

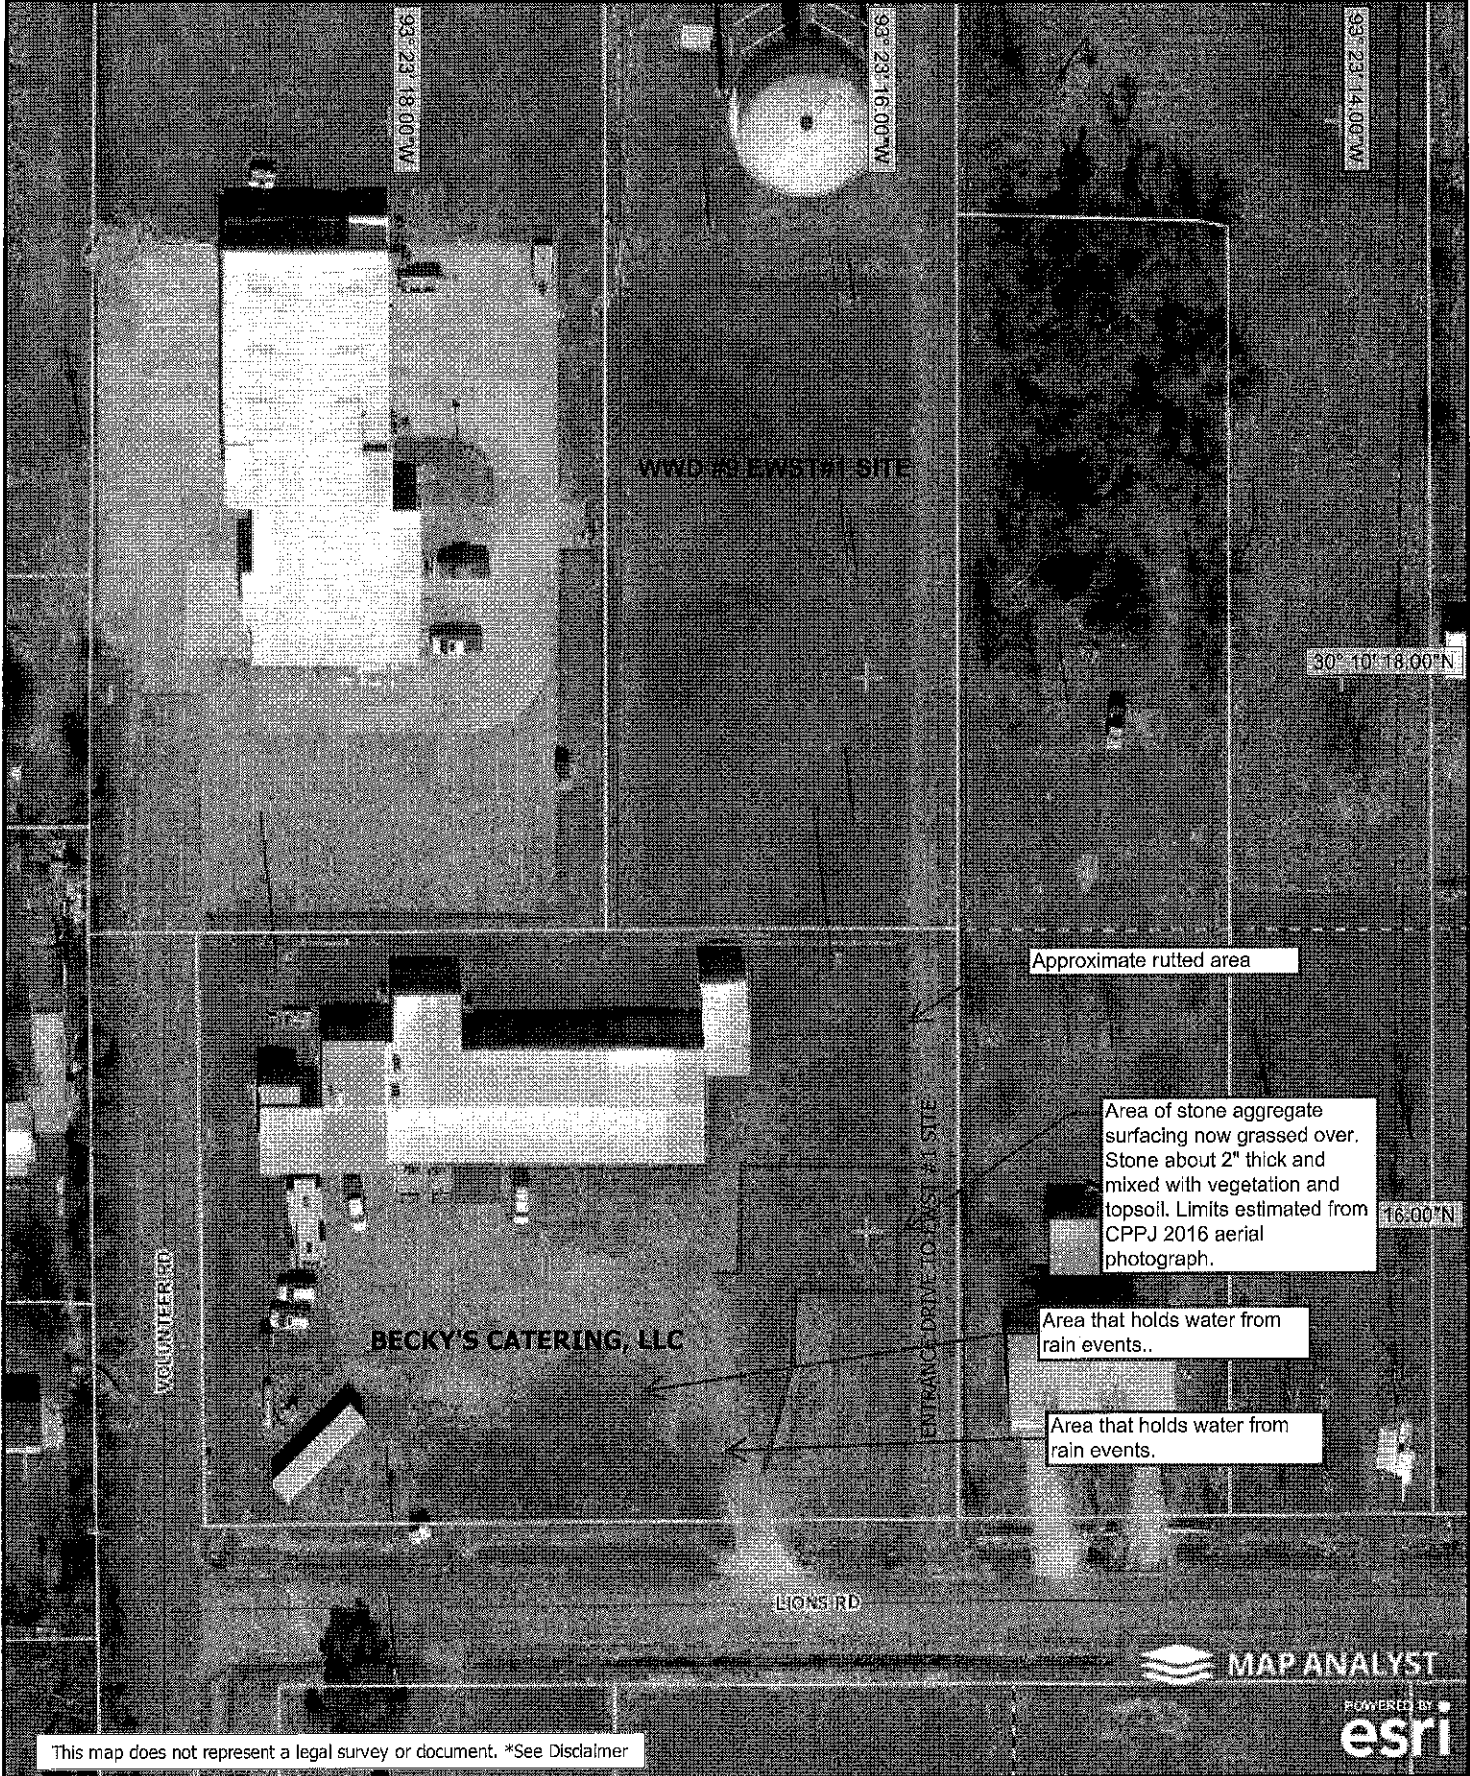
# EXHIBIT 1 SITE MAP

- 2.1. Construction vehicle ruts were observed to be in the area west of the entrance drive into the EWST #1 site as depicted on the attached Exhibit 1 Site Map and in the attached Exhibit 2 Photographs.

- 2.2. The two (2) darkened areas labeled as "Area that holds water from rain events" on the attached Exhibit 1 Site Map were observed to be inundated by water as seen in the Exhibit 2 Photographs.

- 2.3. Ms. Fuselier advised that the rutted area identified in the Exhibit 1 Site Map had been previously covered in aggregate but that over time it had been grassed over. For this reason, she wanted the entire area to be resurfaced with stone aggregate. Jay probed in the area with a sharp shooter shovel to depth of about 16-inches in three (3) different locations and never hit any aggregate material, only topsoil and silty clay. I advised Ms. Fuselier that there was no evidence of stone surfacing in the area and that is why the area rutted. I told her that it would not be reasonable to repair the ruts in the area by resurfacing the entire area with stone. She disagreed and said that since the workers drove construction vehicles onto her property and damaged it, they

- 2.4. Ms. Fuselier also mentioned the standing or ponding water in her aggregate parking lot. Refer to Exhibit 1 Site Map and Exhibit 2 Photographs. She advised that this condition was caused by the construction vehicles. As per the Site Map, the aerial photograph background indicates existing ponding occurring in the dark areas. This photograph was taken in January-February 2022 and therefore the ponding was occurring at that time well before the construction vehicles tracked across her property. In addition, two (2) photographs taken on September 29, 2020 (page 8 of Exhibit 2) show ponding in the same area which pre-dates the construction vehicular damage.

- 3.1. The existing swale ditch along the west side of the entrance drive to EWST #1 should be repaired, shaped, and graded along its entire length to drain south to the existing road ditch along Lions Road. The high spot in the swale ditch located on Ms. Fuselier's property should be removed so that the swale ditch maintains a good constant slope from north to south.
- 3.2. The ruts located on Ms. Fuselier's property should be filled with sand or top soil and the area graded smooth to remove all scars from the ruts. Bare soil areas shall be hand seeded and fertilized.
- 3.3. The two (2) ponding areas located in the aggregate parking lot are old existing low areas and were not created by the construction vehicles tracking across the property. Accordingly, the repair of these areas is not the responsibility of the contractor, Stevens TPC, Inc.

- 4.5. The ruts located on Ms. Fuselier's property west of the entrance drive in the area noted on the Exhibit 1 Site Plan shall be filled with sand or top soil and the area graded smooth to remove all scars from the ruts. Bare soil areas shall be hand seeded and fertilized. The work is the responsibility of Stevens. The cost of this work is \$2,800.
- 4.6. The cost to spread 1 load of 610 limestone aggregate to fill the two (2) low areas in the existing aggregate parking lot is \$2,600. It is the opinion of LEI that this work and cost is not the responsibility of either Stevens or the Water District. It has been provided for informational purposes only.

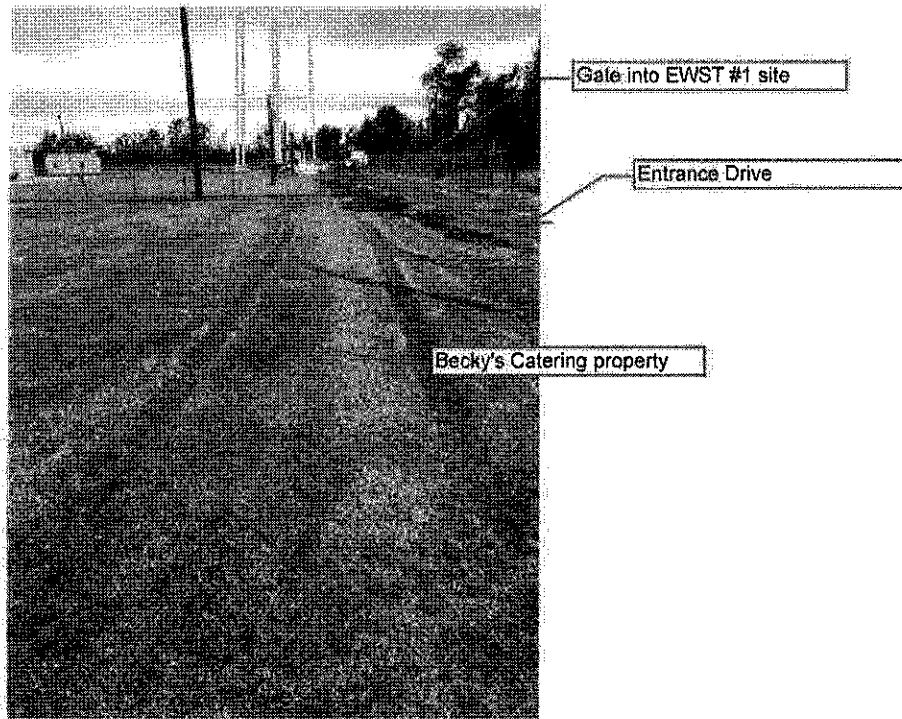
PHOTOGRAPH DESCRIPTION: West side of entrance drive to EWST #1. Note vehicle ruts in foreground and along drive in background. Gate and fencing marks WWD#9 property.

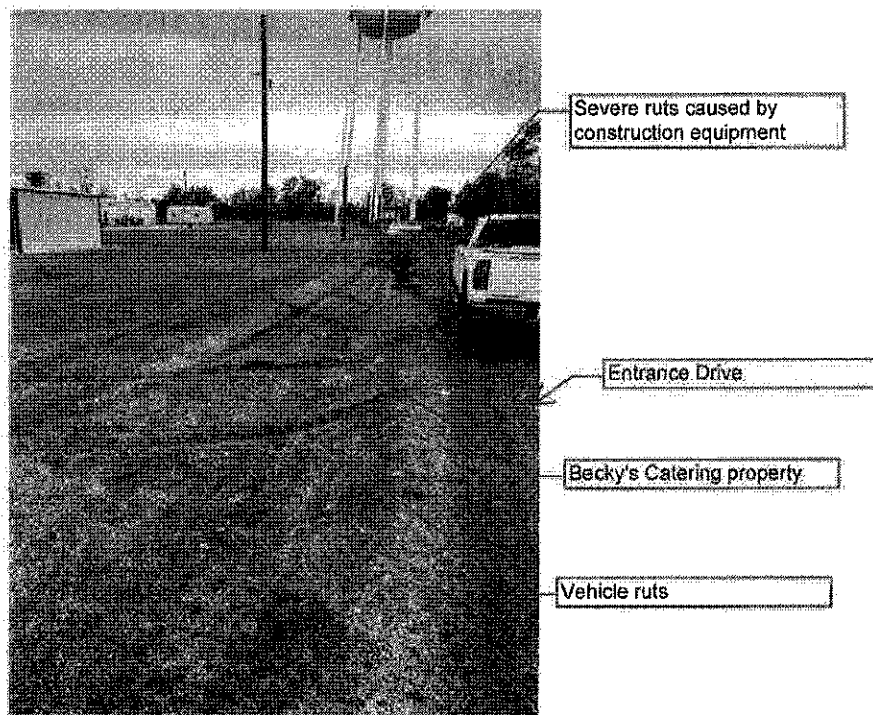
PHOTOGRAPH DESCRIPTION: West side of entrance drive to EWST#1 site looking north.

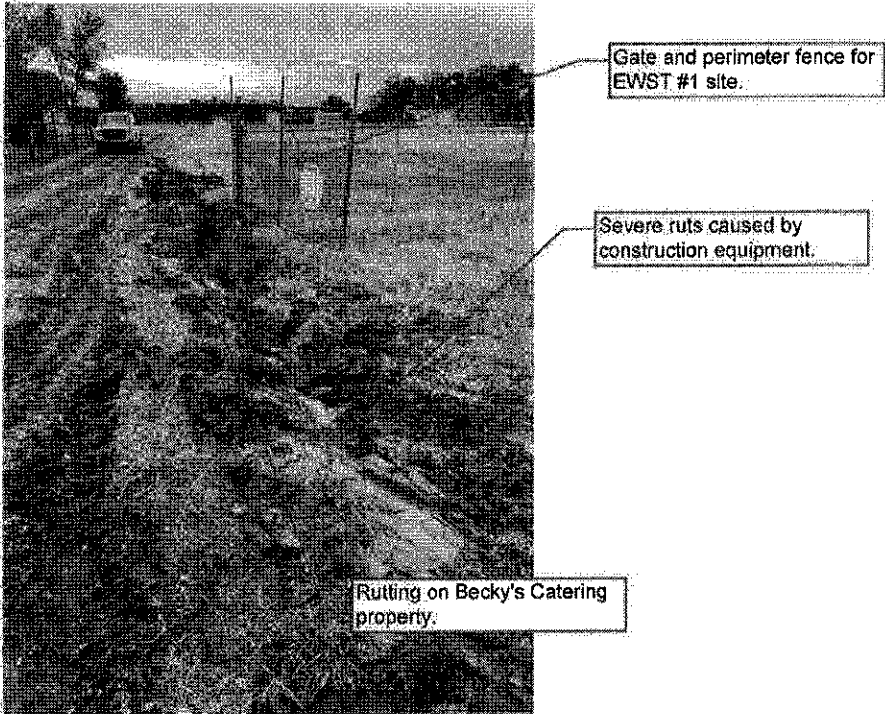
PHOTOGRAPH DESCRIPTION: West side of Entrance Drive to EWST #1, looking south.

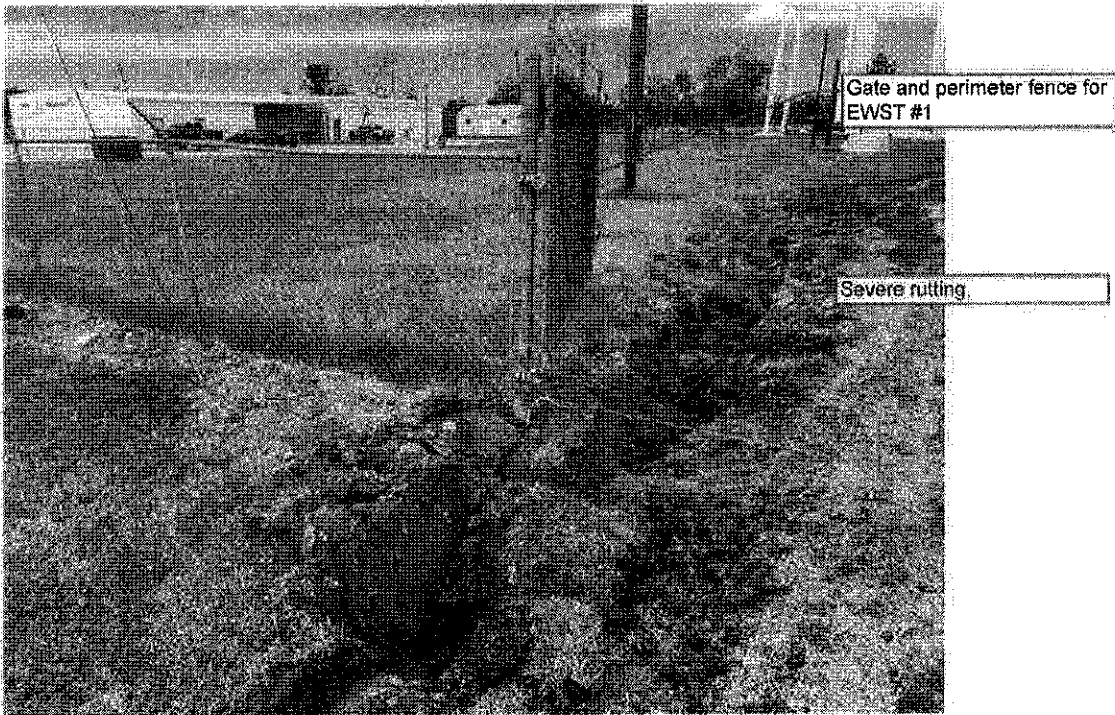
PHOTOGRAPH DESCRIPTION: West side of entrance drive to EWST #1, looking northwest.

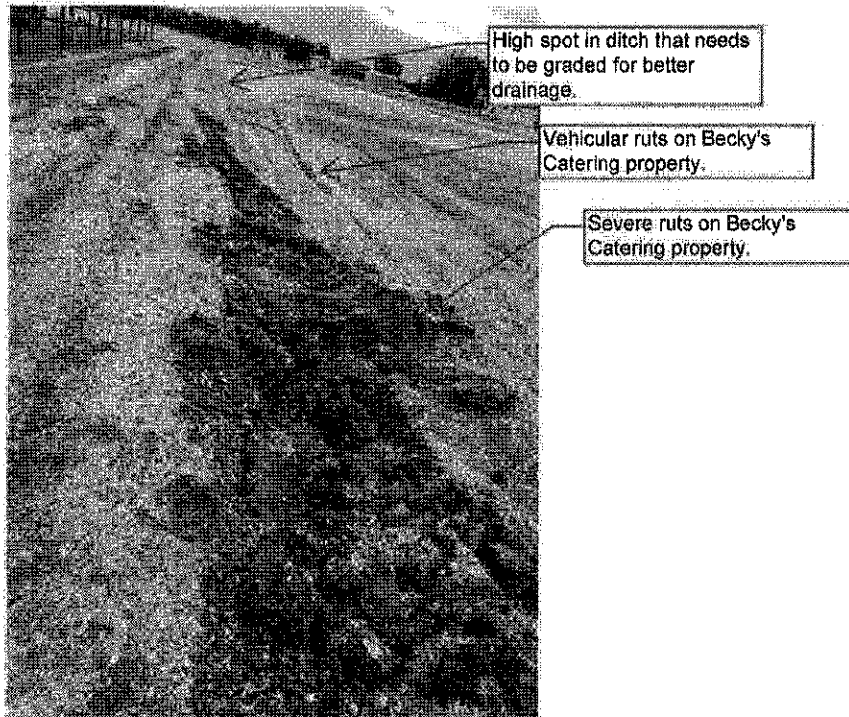
PHOTOGRAPH DESCRIPTION: West side of entrance drive to EWST #1 site , looking south.

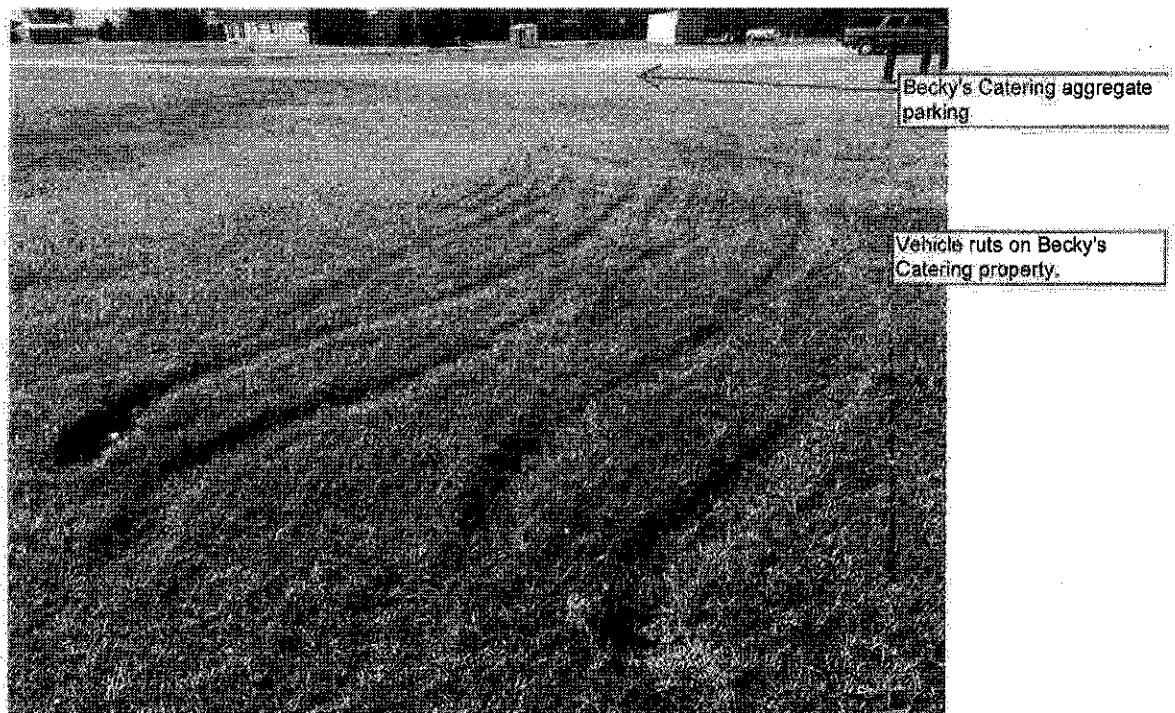
PHOTOGRAPH DESCRIPTION: Becky's Catering property west of entrance drive to EWST #1, looking southwest.

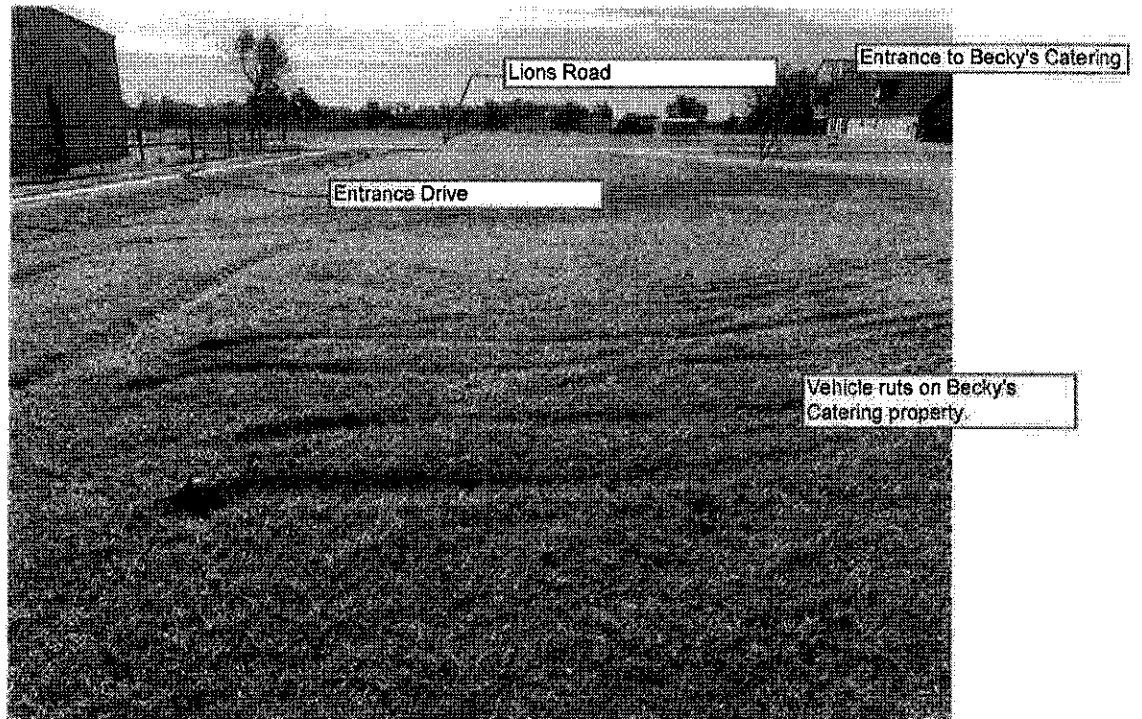
PHOTOGRAPH DESCRIPTION: Becky's Catering property west of entrance drive into EWST #1 site, looking south.

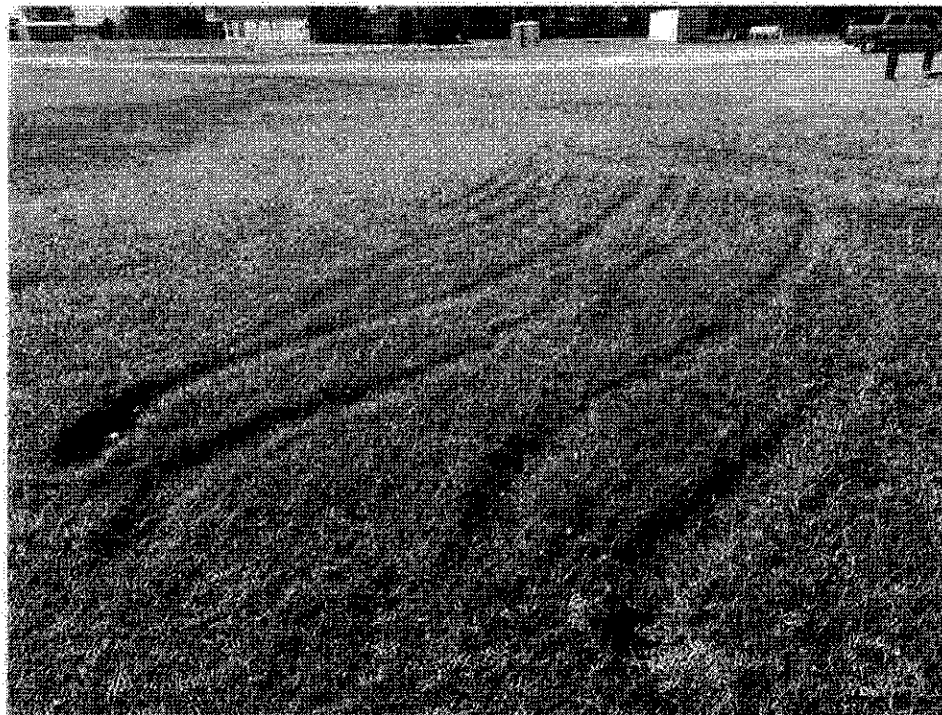
PHOTOGRAPH DESCRIPTION: Same as above with a slightly different view, looking southwest.

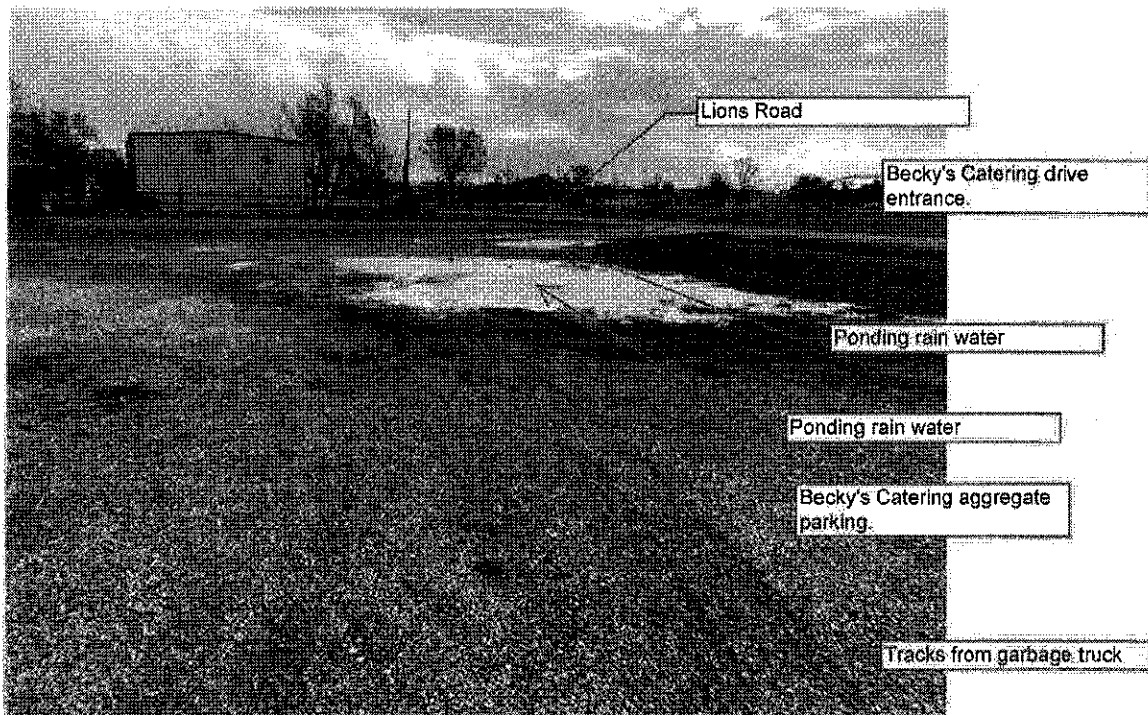
PHOTOGRAPH DESCRIPTION: Standing in front of Becky's Catering building, looking Easterly.

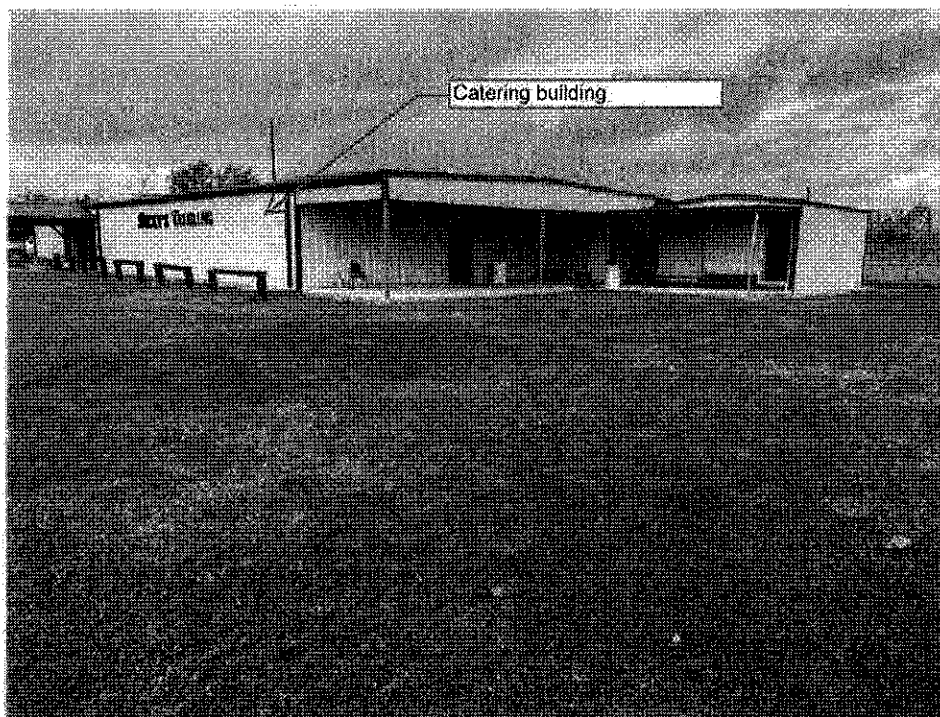
PHOTOGRAPH DESCRIPTION: Becky's Catering property east of their building and west of entrance drive to EWST #1. Looking northwest.

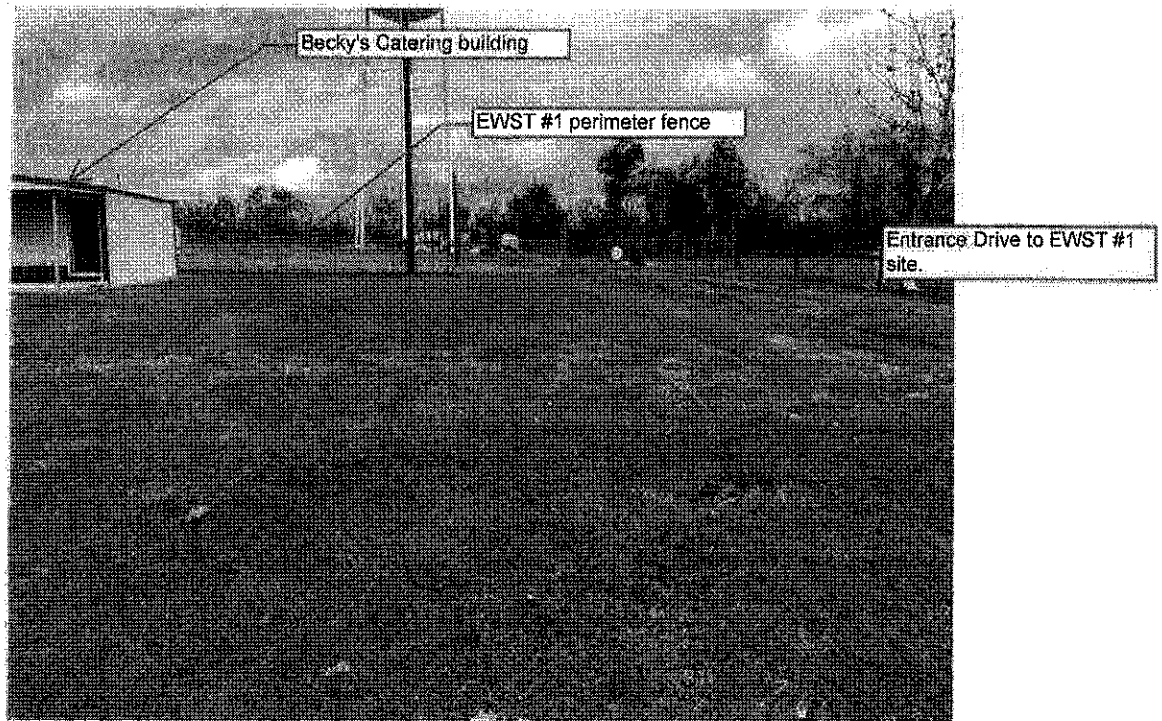
PHOTOGRAPH DESCRIPTION: Becky's Catering property west of entrance drive to EWST #1 site.

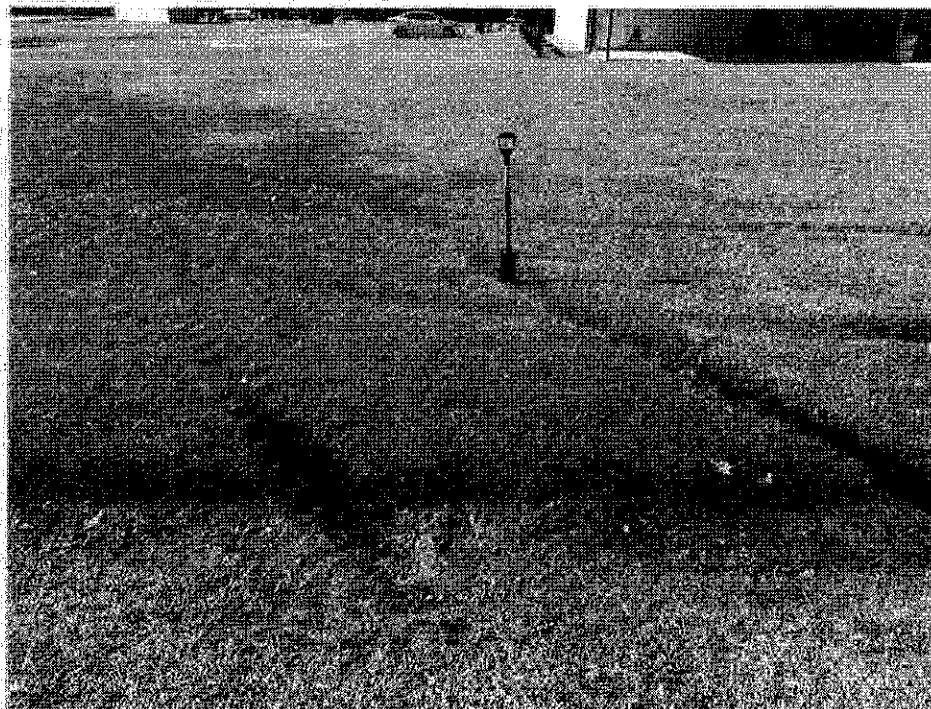
PHOTOGRAPH DESCRIPTION: Ruts in Becky's Catering property west of entrance drive to EWST #1 site. Standing west of entrance drive looking west. Shovel marking the north edge of old aggregate stone surfacing.

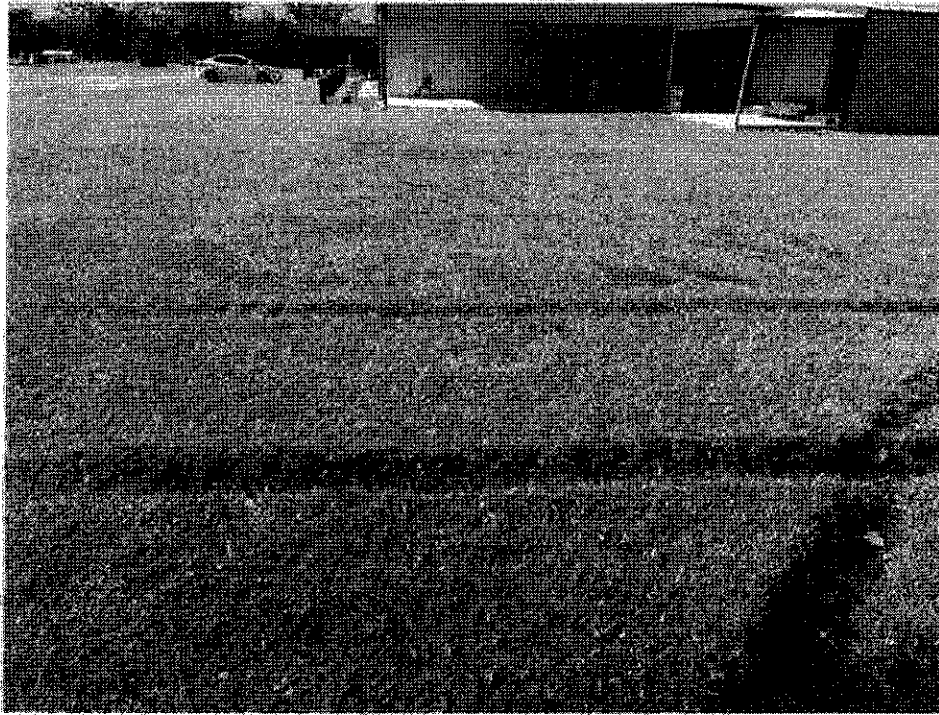
PHOTOGRAPH DESCRIPTION: Ruts in Becky's Catering property west of entrance drive to EWST #1 site. Standing west of entrance drive looking west in line with the front of building.

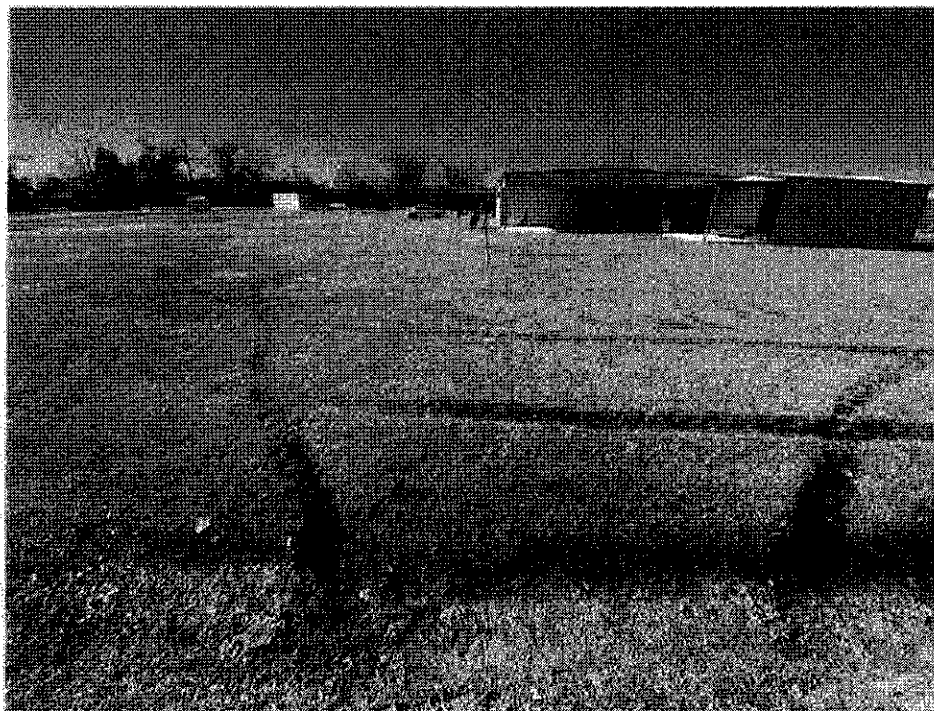
PHOTOGRAPH DESCRIPTION: Ruts in Becky's Catering property west of entrance drive to EWST #1 site. Standing west of entrance drive looking west in line with the front of building.

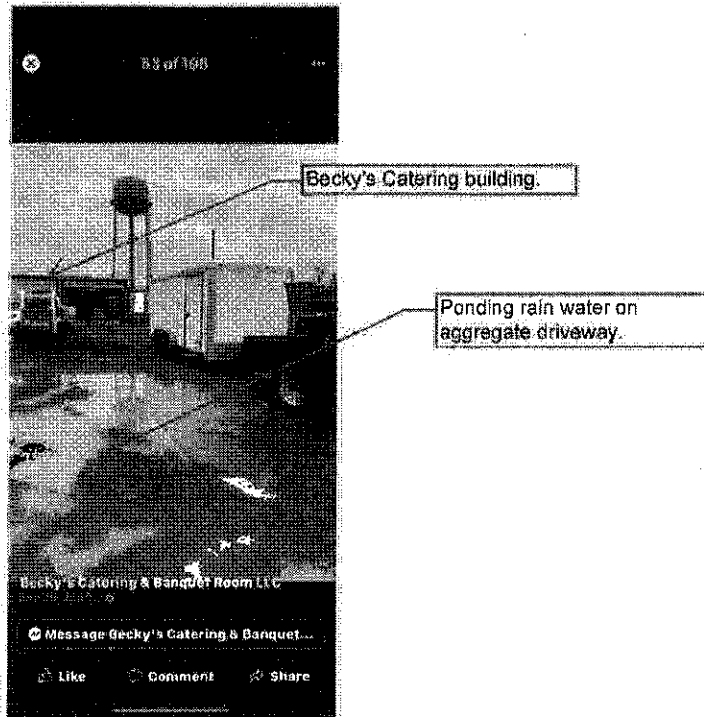
Ponding rain water on aggregate driveway.

PHOTOGRAPH DESCRIPTION: Becky's Catering driveway entrance on September 29, 2020, looking north.
